**The 2002 rock/ice avalanche at Kolka/Karmadon, Russian Caucasus:  
assessment of extraordinary avalanche formation and mobility, and  
application of QuickBird satellite imagery**

# The 2002 rock/ice avalanche at Kolka/Karmadon, Russian Caucasus: assessment of extraordinary avalanche formation and mobility, and application of QuickBird satellite imagery

**Abstract.** A massive rock/ice avalanche of about  $100 \times 10^6 \text{ m}^3$  volume took place on the northern slope of the Kazbek massif, North Ossetia, Russian Caucasus, on 20 September 2002. The avalanche started as a slope failure, that almost completely entrained Kolka glacier, traveled down the Genaldon valley for 20 km, was stopped at the entrance of the Karmadon gorge, and was finally succeeded by a distal mudflow which continued for another 15 km. The event caused the death of ca. 140 people and massive destruction. Several aspects of the event are extraordinary, i.e. the large ice volume involved, the extreme initial acceleration, the high flow velocity, the long travel distance and particularly the erosion of a valley-type glacier, a process not known so far. The analysis of these aspects is essential for proce

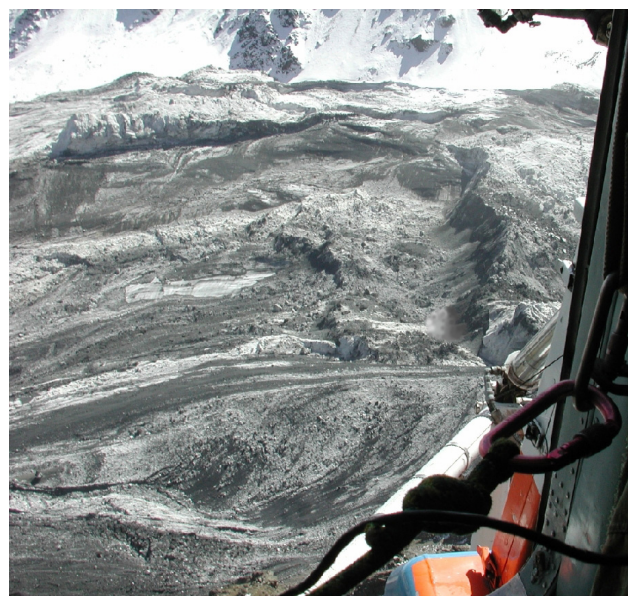
**Fig. 5.** Photograph of eroded Kolka glacier taken two days after the avalanche from the helicopter. The shattered and disrupted ice, and main and secondary flow lines can be recognized.

The further erosion traces of Kolka glacier observed within the first week after the disaster (cf. Figs. 4 and 5) showed a rather chaotic pattern with a general flow direction towards the main valley as well as numerous cross-tracking flows. The erosive features, detachment zones and the shattered and crushed remaining ice are evidence of a massive impact. A comparable situation is not documented in the world and makes this case unique.

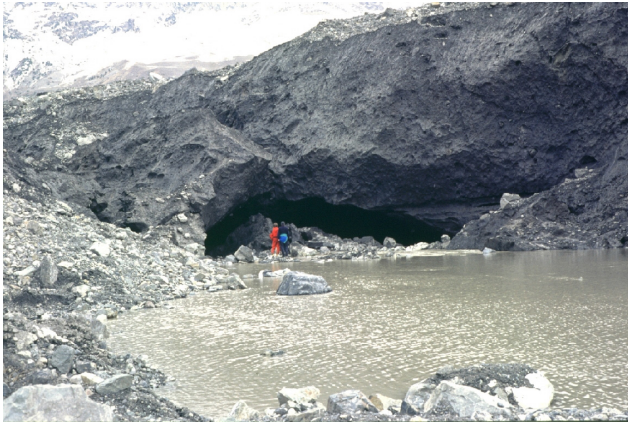
**Fig. 6.** Ice deposits at the Karmadon dam with a small temporary ice-marginal lake. The deposits are mostly composed by disrupted and re-compacted ice covered by a varying thick debris layer. Note the persons for scale (photo by C. Huggel, 8 May 2003).

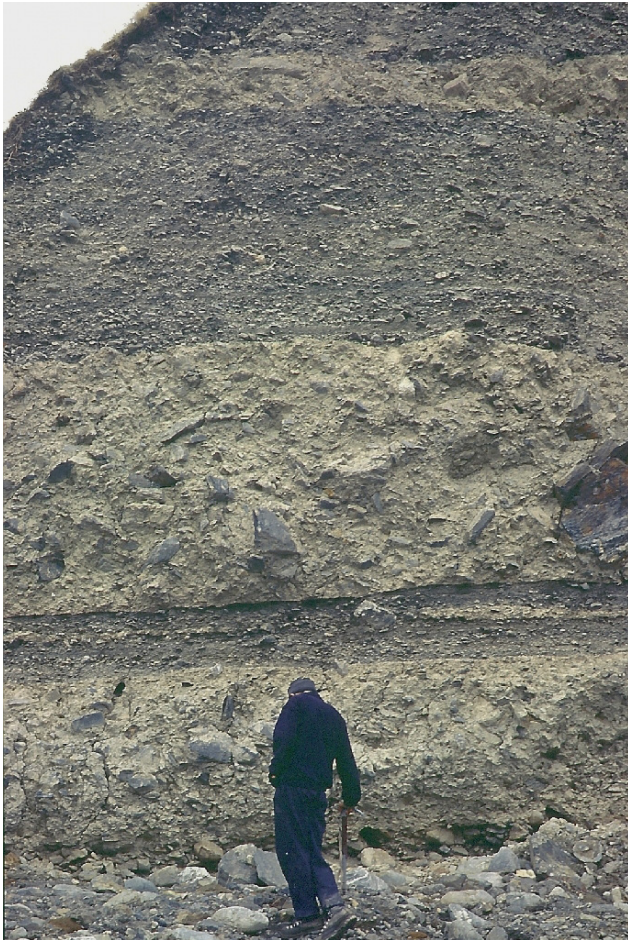
**Fig. 11.** Deposits of at least two major mass movement processes resembling rock avalanches intersected by fluvial sediment accumulations. The deposits were found at the upstream end of the Karmadon ice dam (photo by C. Huggel, 8 May 2003).

- Avalanches involving a volume of ice in the order of 10<sup>8</sup> m<sup>3</sup> are extremely rare. A similar event is historically not documented worldwide and derivation of such events from geological records (deposits) is usually not possible since deposited ice is typically not preserved more than a few years to decades. Yet, in Karmadon deposits of past mass movements were found at the upstream end of the present ice dam (Fig. 11). Fluvial deposits alternate with deposits resembling rock avalanche
